**Flood Control Project Maintenance
Levee Inspections**
LMA District Cover Sheet
Spring 2018 Levee Inspection Results

Sacramento Maintenance Yard Cache Creek

Spring 2018 Levee Inspection Results

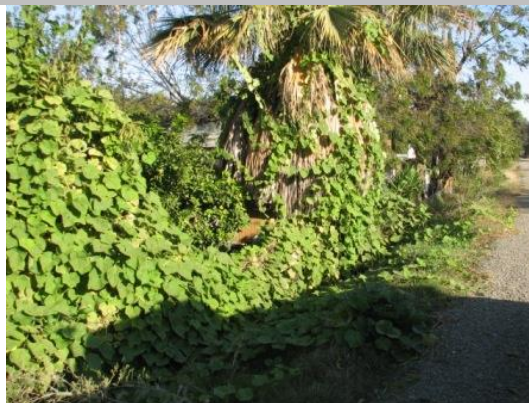
Photo 1 of 2 : SP_2018_ST0001_259_7_20180306_00007.jpg

LM Start	1.98	Rating **	M	Issue No.	7
LM End	2.01	Issue Type +	En	Location *	LS
Category	Earthen Levee			GPS Latitude/Longitude	
				Start	End
Item	Encroachments			38.731167 °	38.731614 °
				-121.806217 °	-121.806032 °
DWR ID	DWR_ST0001_01_s_2012_7				
Comment Code					
FE : Fence					
Inspector Comment

Wild grape and other plants are obstructing the view for inspection. Fall 2011

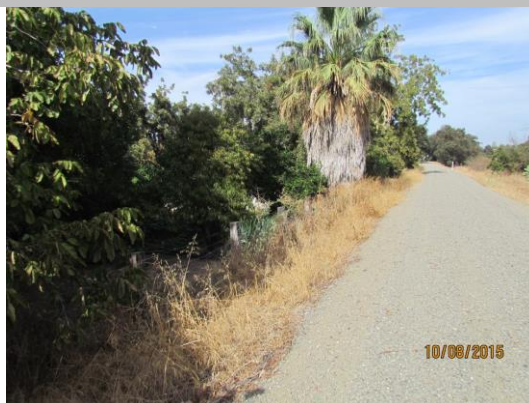
Photo 2 of 2 : SP_2018_ST0001_259_7_20180306_00008.jpg

View of the landscaping on the landward side of the levee looking downstream. Fall 2015.

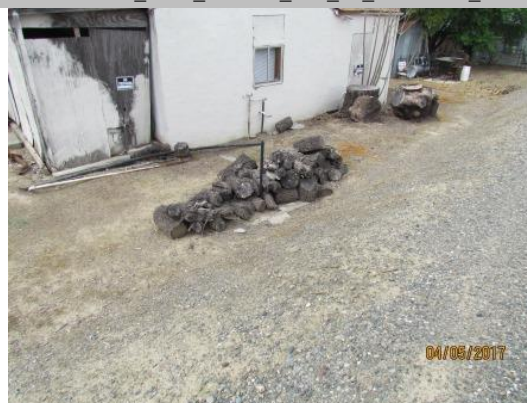
Photo 1 of 1 : SP_2018_ST0001_259_82_20180306_00051.jpg

LM Start	2.03	Rating **	M	Issue No.	82
LM End	2.03	Issue Type +	En	Location *	LS
Category	Earthen Levee			GPS Latitude/Longitude	
				Start	End
Item	Encroachments			38.731818 °	38.731818 °
				-121.805941 °	-121.805941 °
DWR ID	DWR_ST0001_01_s_2017_82				
Comment Code					
FW : Firewood					
Inspector Comment					
Firewood pile at landside levee toe.

Firewood pile at landside levee toe. Spring 2017.

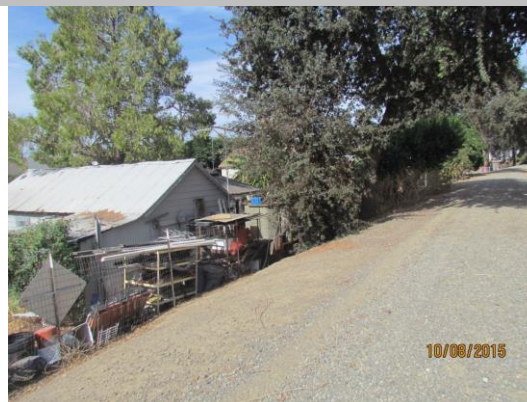
Photo 1 of 1 : SP_2018_ST0001_259_11_20180306_00011.jpg

LM Start	2.06	Rating **	M	Issue No.	11
LM End	2.06	Issue Type +	En	Location *	LS
Category	Earthen Levee			GPS Latitude/Longitude	
				Start	End
Item	Encroachments			38.732268 °	38.732268 °
				-121.805832 °	-121.805832 °
DWR ID	DWR_ST0001_01_s_2012_11				
Comment Code					
BU : Building					
Inspector Comment

View of the building on the landward side of the levee looking downstream. Fall 2015.

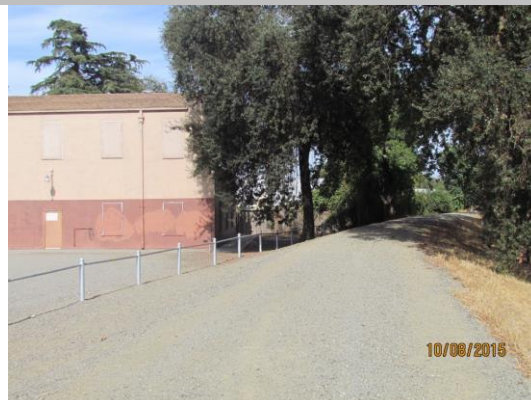
Photo 1 of 1 : SP_2018_ST0001_259_12_20180306_00012.jpg

LM Start	2.12	Rating **	M	Issue No.	12
LM End	2.12	Issue Type +	En	Location *	LS
Category	Earthen Levee			GPS Latitude/Longitude	
				Start	End
Item	Encroachments			38.733000 °	38.733000 °
				-121.805409 °	-121.805409 °
DWR ID	DWR_ST0001_01_s_2012_12				
Comment Code					
BU : Building					
Inspector Comment

View of the building on the landward side of the levee looking downstream. Fall 2015.

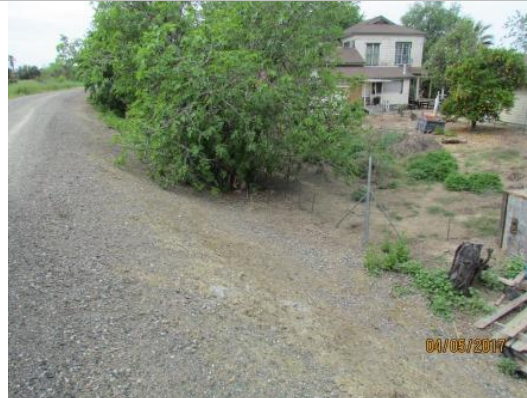
Photo 1 of 1 : SP_2018_ST0001_259_77_20180306_00048.jpg

LM Start	2.62	Rating **	M	Issue No.	77
LM End	2.64	Issue Type +	En	Location *	LS
Category	Earthen Levee			GPS Latitude/Longitude	
				Start	End
Item	Encroachments			38.732795 °	38.732897 °
				-121.797050 °	-121.796547 °
DWR ID	DWR_ST0001_01_s_2017_77				
Comment Code					
FE : Fence					
Inspector Comment					
Wire fence at landside toe.

Chain fence at landside levee toe. Spring 2017.

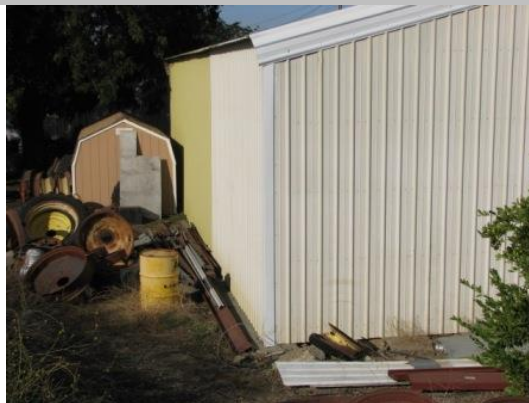
Photo 1 of 2 : SP_2018_ST0001_259_20_20180306_00020.jpg

LM Start	2.69	Rating **	M	Issue No.	20
LM End	2.69	Issue Type +	En	Location *	LS
Category	Earthen Levee			GPS Latitude/Longitude	
				Start	End
Item	Encroachments			38.733145 °	38.733145 °
				-121.795845 °	-121.795845 °
DWR ID	DWR_ST0001_01_s_2012_20				
Comment Code					
BU : Building					
Inspector Comment

The corner of the shop is within the easement of the levee. Fall 2011

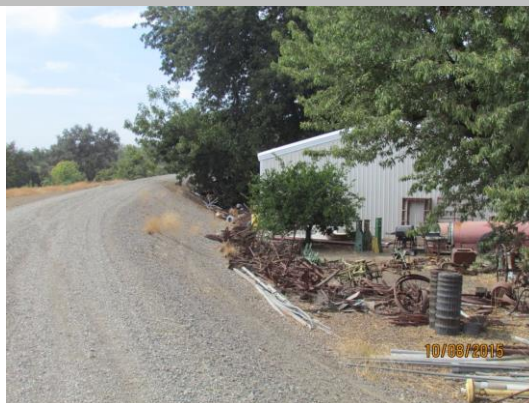
Photo 2 of 2 : SP_2018_ST0001_259_20_20180306_00021.jpg

View of the building on the landward side of the levee looking upstream. Fall 2015.

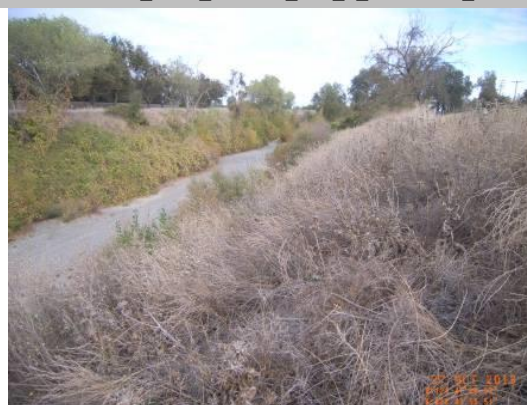
Photo 1 of 1 : SP_2018_ST0001_259_1_20180306_00001.jpg

LM Start	3.48	Rating **	A/W	Issue No.	1
LM End	3.57	Issue Type +	Ma	Location *	WS
Category	Supplemental			GPS Latitude/Longitude	
				Start	End
Item	2015 USACE Erosion Survey, DRAFT			38.732942 °	38.731626 °
				-121.784965 °	-121.785231 °
DWR ID	DWR_ST0001_01_s_2016_1				
Comment Code					
Inspector Comment					
2006 - Some significant new erosion, especially fresh upper bank slumping. Still substantial berm. 2010 - Site extended downstream, some new erosion, heavily vegetated and hard to see. Planned setback levee by CA DWR, 60% design complete, construction planned for 2012. 2011 - Construction delayed to 2013 - 2014. 2015: No observed changes. [2015 Site ID: CHC_3-4_L]

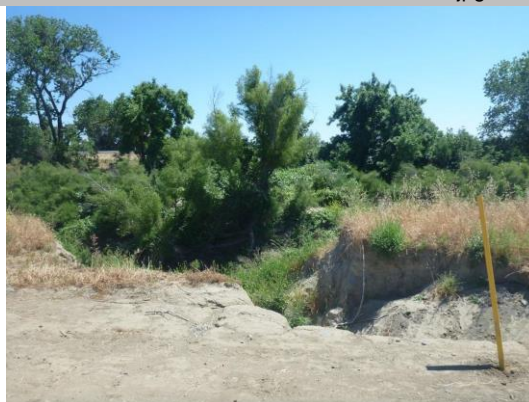
LM Start	4.22	Rating **	A/W	Issue No.	34
LM End	4.23	Issue Type +	Ma	Location *	WS
Category	Supplemental			GPS Latitude/Longitude	
				Start	End
Item	2017 Storm Damage			38.727207 °	38.727187 °
				-121.775521 °	-121.775450 °
DWR ID	DWR_ST0001_01 f _2017_34

Repair Type: Erosion

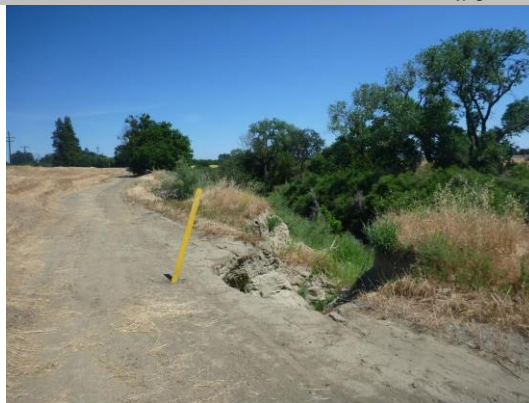
Photo 3 of 3 : LEVAL_SP_2018_249_960.jpg

LM Start	4.22	Rating **	A/W	Issue No.	34 (cont)
LM End	4.23	Issue Type +	Ma	Location *	WS
Category	Supplemental			GPS Latitude/Longitude	
				Start	End
Item	2017 Storm Damage			38.727207 °	38.727187 °
				-121.775521 °	-121.775450 °
DWR ID	DWR_ST0001_01_f_2017_34				
Comment Code					
Inspector Comment					
Levee Evaluation Comments					
Description:					
Site ID No:249					
Site Designation:LMA-57					
Repair Type: Erosion					
Rating:Area of Concern					
Field Date:6/2/2017					
Notes: setback levee site; remaining berm greater than 86 feet, no section taken, photo only.

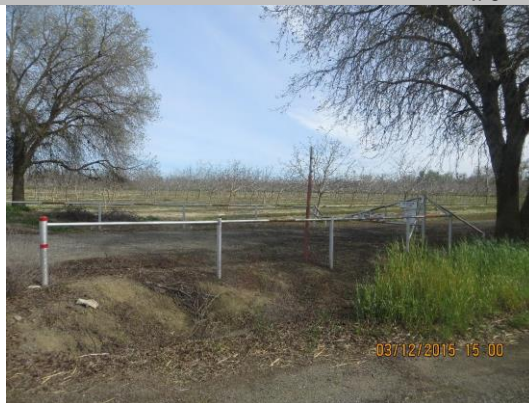
Photo 1 of 2 : UCIP_SP_2018_49112_73504.jpg

Gasline marker next to levee access gate 500-feet north of levee crown.

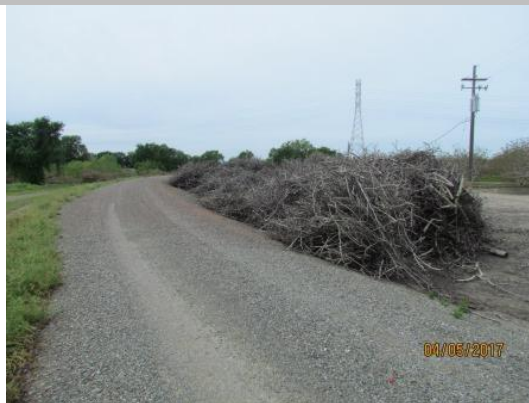
Photo 1 of 2 : SP_2018_ST0001_259_45_20180306_00034.jpg

LM Start	5.74	Rating **	M	Issue No.	45
LM End	5.74	Issue Type +	En	Location *	LS
Category	Earthen Levee			GPS Latitude/Longitude	
				Start	End
Item	Encroachments			38.723732 °	38.723732 °
				-121.754568 °	-121.754568 °
DWR ID	DWR_ST0001_01_s_2016_45				
Comment Code					
PR : Prunings					
Inspector Comment					
Pruning pile has been reduced to a single location 20' pile.

View of prunings on landside slope. Spring 2017.

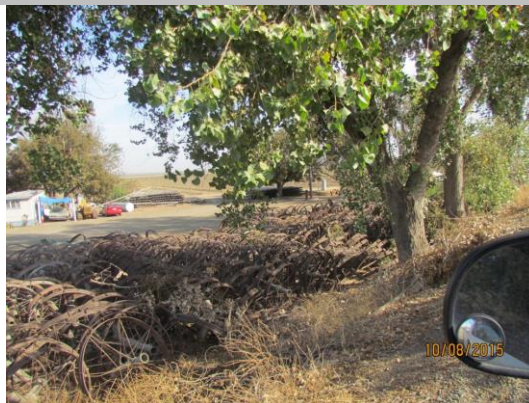
Photo 2 of 2 : SP_2018_ST0001_259_40_20180306_00033.jpg

LM Start	7.30	Rating **	M	Issue No.	40 (cont)	
LM End	7.34	Issue Type +	En	Location *	LS	
Category	Earthen Levee			GPS Latitude/Longitude		
				Start		End
Item	Encroachments			38.727878 °		38.728085 °
				-121.728553 °		-121.727740 °
DWR ID	DWR_ST0001_01_s_2012_40					
Comment Code						
EQ : Equipment						
Inspector Comment

View of the equipment at the levee toe on the landward side looking downstream. Fall 2015.

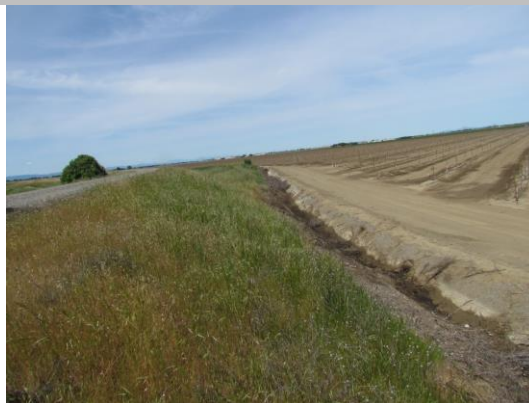
Photo 1 of 2 : SP_2018_ST0001_259_26_20180306_00023.jpg

LM Start	7.36	Rating **	M	Issue No.	26
LM End	7.78	Issue Type +	En	Location *	LS
Category	Earthen Levee			GPS Latitude/Longitude	
				Start	End
Item	Encroachments			38.728188 °	38.728194 °
				-121.727442 °	-121.720255 °
DWR ID	DWR_ST0001_01_s_2015_26				
Comment Code					
DT : Ditch					
Inspector Comment					
Ditch is located at the levee toe.

View of ditch on the landward side of the levee looking upstream. Spring 2015.

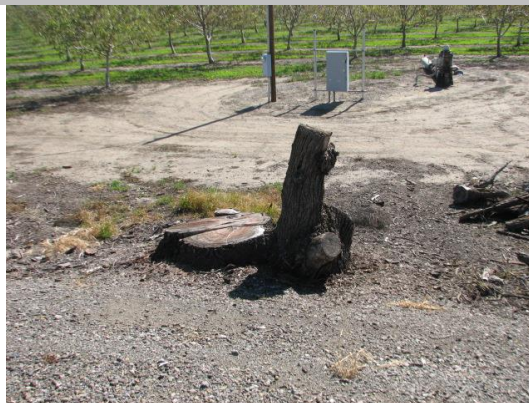
Photo 1 of 1 : SP_2018_ST0001_260_6_20180306_00007.jpg

LM Start	0.27	Rating **	N	Issue No.	6
LM End	0.27	Issue Type +	Ma	Location *	LS
Category	Earthen Levee			GPS Latitude/Longitude	
				Start	End
Item	Trim / Thin Trees			38.730723 °	38.730723 °
				-121.804972 °	-121.804972 °
DWR ID	DWR_ST0001_02_s_2014_6				
Comment Code					
T5 : Tree stumps.					
Inspector Comment

A large black walnut tree stump is at the toe of the levee. Spring 2014

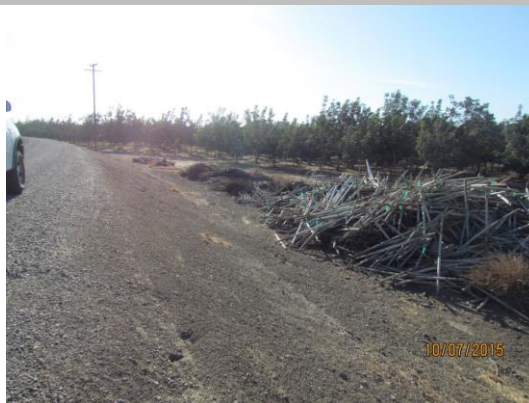
Photo 1 of 1 : SP_2018_ST0001_260_1_20180306_00001.jpg

LM Start	0.70	Rating **	M	Issue No.	1
LM End	0.70	Issue Type +	En	Location *	LS
Category	Earthen Levee			GPS Latitude/Longitude	
				Start	End
Item	Encroachments			38.732190 °	38.732190 °
				-121.798852 °	-121.798852 °
DWR ID	DWR_ST0001_02_s_2012_1				
Comment Code					
DE : Debris					
Inspector Comment					
Prunings and wooden stakes on landward side.

View of the prunings and stakes at the toe of the landward side of the levee looking downstream. Fall 2015.

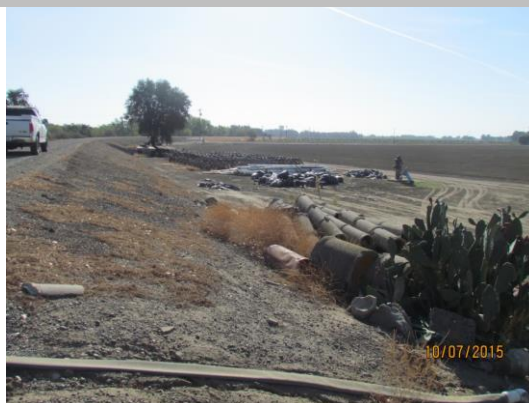
Photo 2 of 2 : SP_2018_ST0001_260_3_20180306_00004.jpg

View of the concrete pile at the toe of the landward side of the levee looking downstream. Fall 2015.

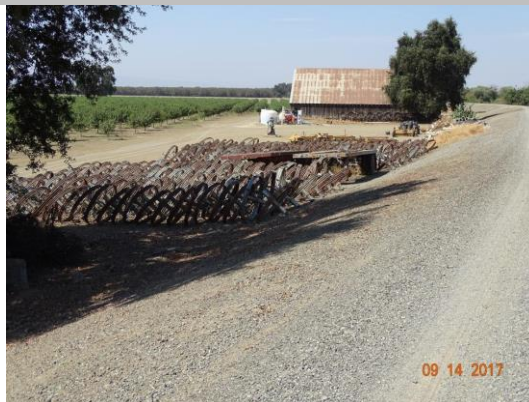
Photo 1 of 1 : SP_2018_ST0001_260_29_20180306_00022.jpg

LM Start	2.43	Rating **	M	Issue No.	29
LM End	2.47	Issue Type +	En	Location *	LS
Category	Earthen Levee			GPS Latitude/Longitude	
				Start	End
Item	Encroachments			38.726036 °	38.725836 °
				-121.774340 °	-121.773688 °
DWR ID	DWR_ST0001_02_f_2017_29				
Comment Code					
EQ : Equipment					
Inspector Comment					
Farm equipment at landside toe.

View of farm equipment at landside toe. Fall 2017.

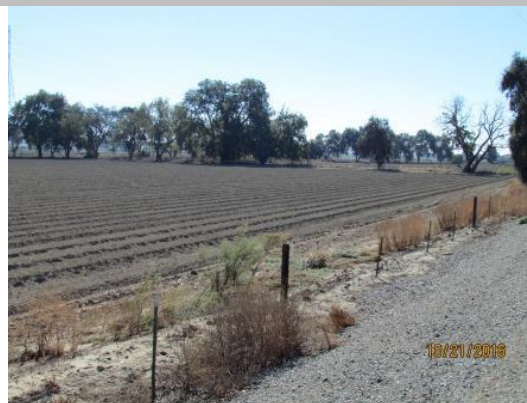
Photo 1 of 1 : SP_2018_ST0001_260_15_20180306_00016.jpg

LM Start	3.14	Rating **	M	Issue No.	15
LM End	3.52	Issue Type +	En	Location *	LS
Category	Earthen Levee			GPS Latitude/Longitude	
				Start	End
Item	Encroachments			38.720022 °	38.722053 °
				-121.763913 °	-121.759600 °
DWR ID	DWR_ST0001_02_f_2016_15				
Comment Code					
FE : Fence					
Inspector Comment					
Wire fence at landside toe.

View of fence on LS slope. Fall 2016.

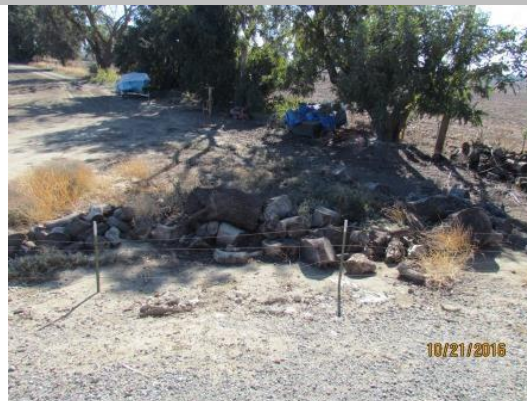
Photo 1 of 1 : SP_2018_ST0001_260_17_20180306_00018.jpg

LM Start	3.39	Rating **	M	Issue No.	17
LM End	3.39	Issue Type +	En	Location *	LS
Category	Earthen Levee			GPS Latitude/Longitude	
				Start	End
Item	Encroachments			38.720204 °	38.720204 °
				-121.759760 °	-121.759760 °
DWR ID	DWR_ST0001_02_f_2016_17				
Comment Code					
FW : Firewood					
Inspector Comment					
Firewood pile behind wire fence.

View of firewood at LS levee toe. Fall 2016.

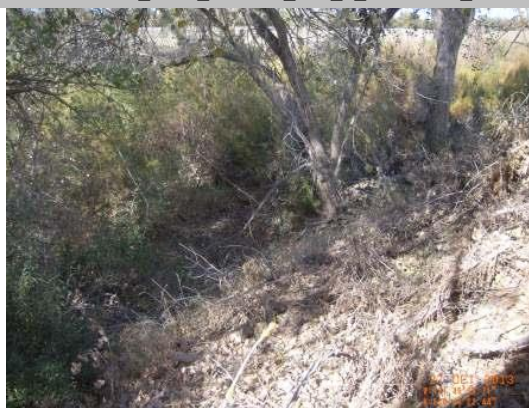
Photo 1 of 1 : SP_2018_ST0001_260_2_20180306_00002.jpg

LM Start	3.53	Rating **	A/W	Issue No.	2
LM End	3.60	Issue Type +	Ma	Location *	WS
Category	Supplemental			GPS Latitude/Longitude	
				Start	End
Item	2015 USACE Erosion Survey, DRAFT			38.722138 °	38.723294 °
				-121.759736 °	-121.759588 °
DWR ID	DWR_ST0001_02_s_2016_2				
Comment Code					
Inspector Comment					
2010 - Large slump on the upper berm, a tree has recently slid down the slope. 2011 - Large slump and new erosion. 2012 - Slightly steeper slopes and cracks observed. 2015: No observed changes. [2015 Site ID: CHC_3-5_R]

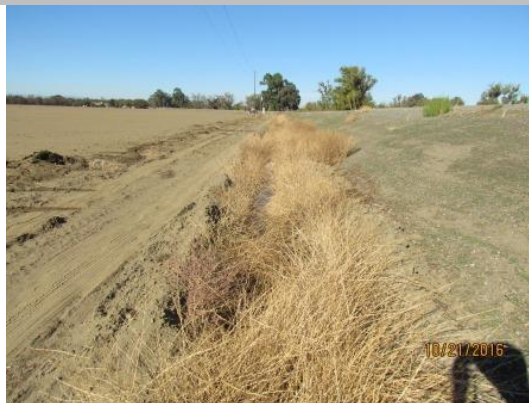
Photo 2 of 2 : SP_2018_ST0001_260_14_20180306_00015.jpg

LM Start	4.69	Rating **	M	Issue No.	14 (cont)	
LM End	4.80	Issue Type +	En	Location *	LS	
Category	Earthen Levee			GPS Latitude/Longitude		
				Start		End
Item	Encroachments			38.727588 °		38.727158 °
				-121.742387 °		-121.740499 °
DWR ID	DWR_ST0001_02_s_2016_14					
Comment Code						
DT : Ditch						
Inspector Comment

View of ditch on landside near the levee toe looking upstream of Cache Creek. Fall 2016.

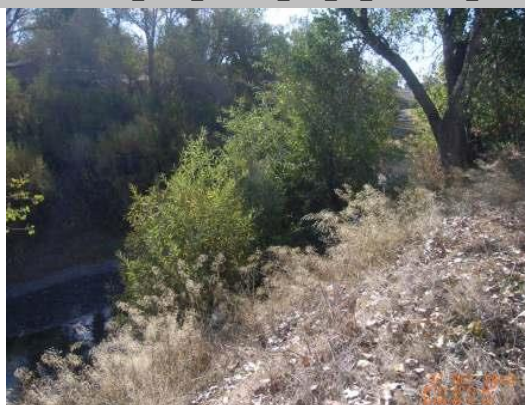
Photo 1 of 1 : SP_2018_ST0001_260_13_20180306_00013.jpg

LM Start	5.33	Rating **	A/W	Issue No.	13
LM End	5.37	Issue Type +	Ma	Location *	WS
Category	Supplemental			GPS Latitude/Longitude	
				Start	End
Item	2015 USACE Erosion Survey, DRAFT			38.722933 °	38.723467 °
				-121.760561 °	-121.760436 °
DWR ID	DWR_ST0001_02_s_2016_13				
Comment Code					
Inspector Comment					
2009 - Erosion into the levee slope. 2010 - Minor new erosion. 2011 - New erosion and a freshly fallen tree. 2012 - New animal holes and slightly steeper slopes. 2013 - New tree popout and 2 feet of erosion along the top bank. 2015: No observed changes. [2015 Site ID: CHC_5-4_L]

USACE 2013 Photo #1

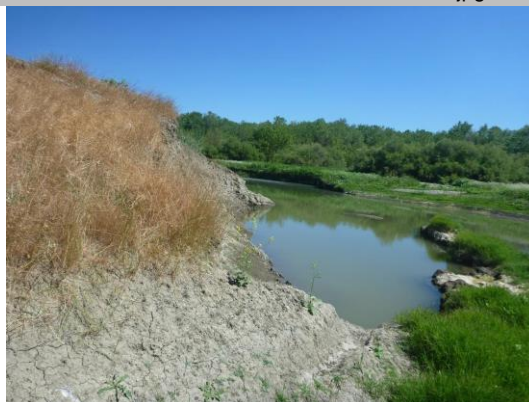
Photo 2 of 3 : LEVAL_SP_2018_250_964.jpg

LM Start	2.26	Rating **	M	Issue No.	1	
LM End	2.26	Issue Type +	Ma	Location *		
Category	Supplemental			GPS Latitude/Longitude		
				Start	End	
Item	2017 Storm Damage			38.695424 °	38.695253 °	
				-121.715914 °	-121.715926 °	
DWR ID	DWR_ST0001_04_f_2017_1					
Comment Code						
Inspector Comment						
Levee Evaluation Comments						
Description:						
Site ID No:250						
Site Designation:LMA-58						
Repair Type: Erosion						
Rating:Area of Concern						
Field Date:6/2/2017						
Notes: training levee end slope where it keys into channel /access ramp erosion

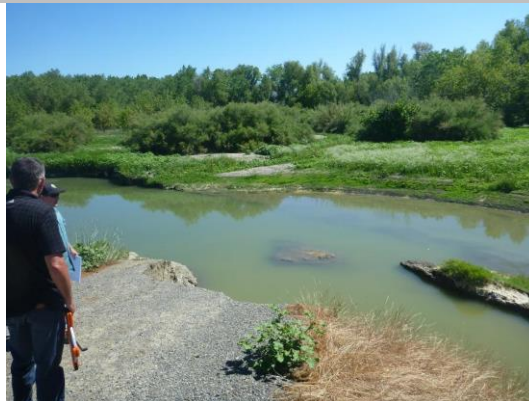
Photo 3 of 3 : LEVAL_SP_2018_250_973.jpg

LM Start	2.26	Rating **	M	Issue No.	1 (cont)	
LM End	2.26	Issue Type +	Ma	Location *		
Category	Supplemental			GPS Latitude/Longitude		
				Start	End	
Item	2017 Storm Damage			38.695424 °	38.695253 °	
				-121.715914 °	-121.715926 °	
DWR ID	DWR_ST0001_04_f_2017_1					
Comment Code						
Inspector Comment						
Levee Evaluation Comments						
Description:						
Site ID No:250						
Site Designation:LMA-58						
Repair Type: Erosion						
Rating:Area of Concern						
Field Date:6/2/2017						
Notes: training levee end slope where it keys into channel /access ramp erosion

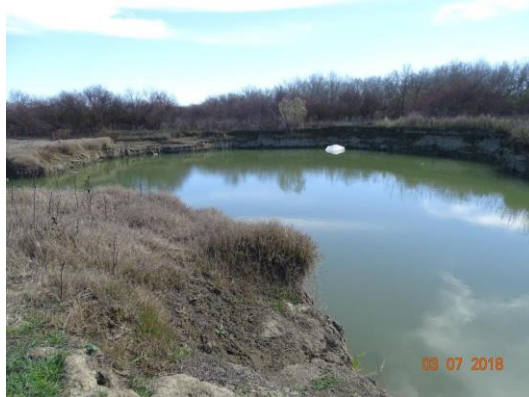
Photo 2 of 4 : SP_2018_ST0001_261_3_20180308_00007.jpg

LM Start	2.26	Rating **	A/W	Issue No.	3 (cont)	
LM End	2.26	Issue Type +	Ma	Location *	WS	
Category	Earthen Levee			GPS Latitude/Longitude		
				Start		End
Item	Erosion / Bank Caving			38.695416 °		38.695416 °
				-121.715943 °		-121.715943 °
DWR ID	DWR_ST0001_04_s_2017_3					
Comment Code						
E2 : Schedule repair of erosion site prior to the next inspection.						
Inspector Comment						
Scour on waterside levee slope at end of Unit 04 levee. There is no visible active erosion at this time, however future high water events will likely cause further erosion into the levee prism.

View of newly scoured pond adjacent to the levee. Spring 2018.

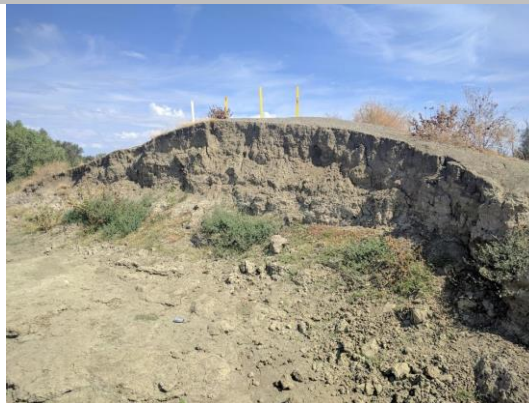
Photo 3 of 4 : SP_2018_ST0001_261_3_20180306_00004.jpg

View of scour at the end of the Training Levee. Ramp is inaccessible at this time. Fall 2017.
